# Dahl Memorial Medical Clinic

## Alaska Rural Primary Care Facility

### Assessment and Inventory Report

**November 12, 2002**

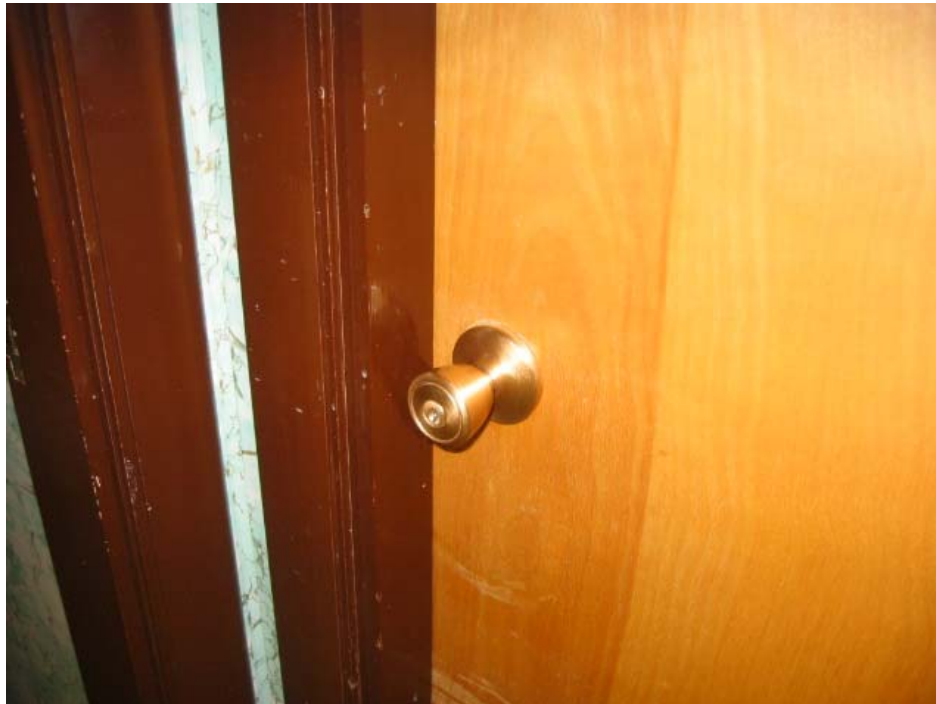
Reference  
Number: **Ask03**

- d. Exterior Doors: The exterior doors are insulated hollow metal or glass and are in fair condition with the exception of the door hardware which is not ADA compliant.

Description: **Provide and install new interior doors with ADA compliant hardware.**

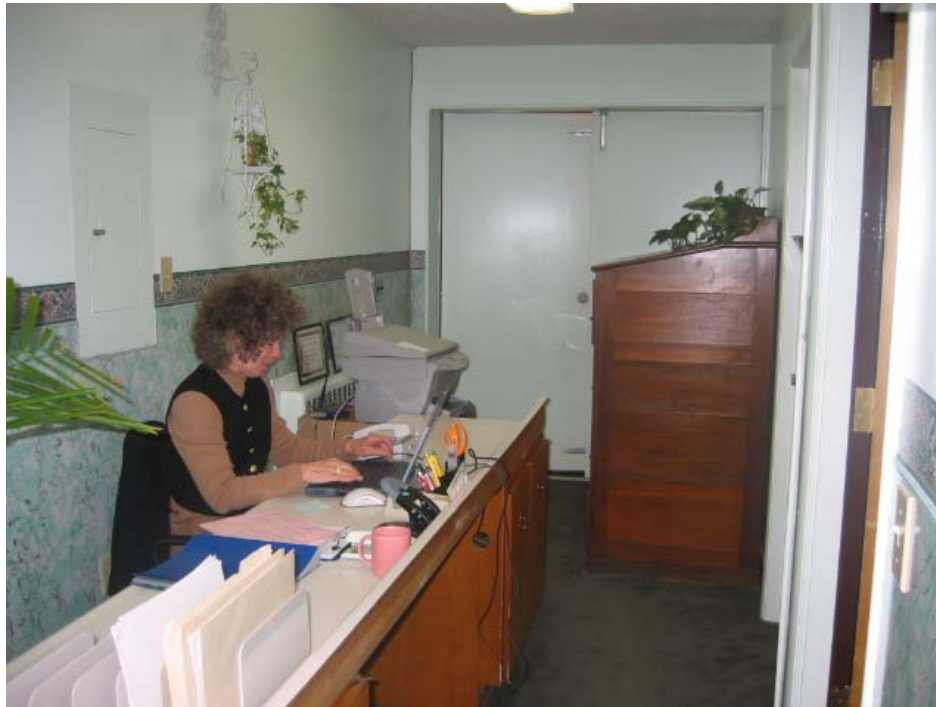
Reference  
Number: **Ask04**

a. Overall Space Deficiencies: The Skagway clinic exceeds ARPCF space requirements by approximately 1623 SF; however, the facility is deficient in office space and lacks arctic entries. The laundry room, although not included in program requirements, is too small, blocking electrical panels and needs to be expanded.

Description: **Add 150 square foot office for records clerk.**

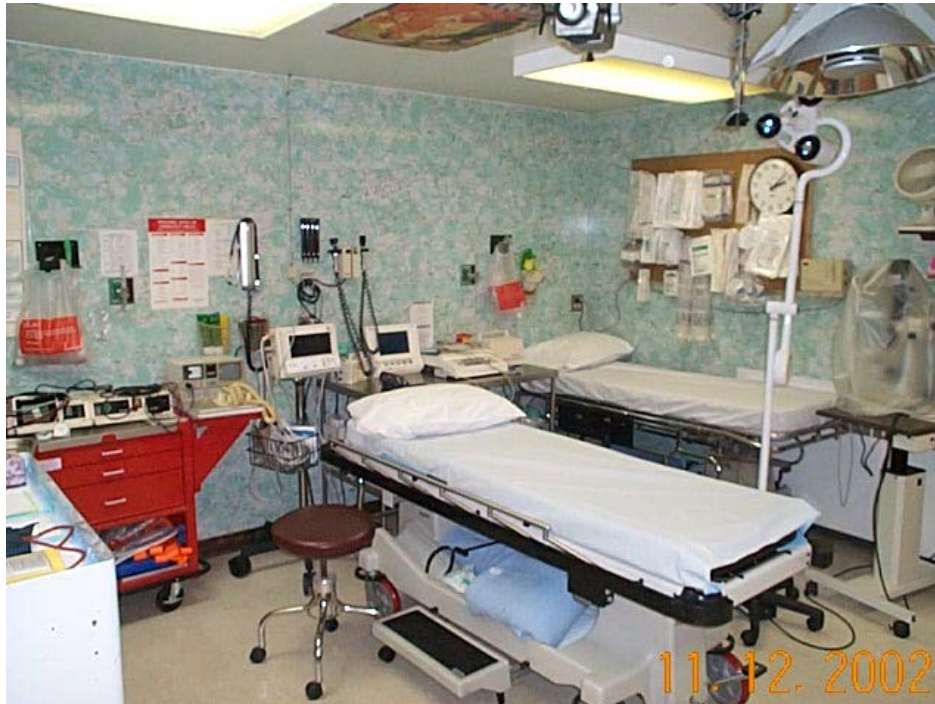
Reference  
Number: **Msk01**

- a. Supply Air System: The laboratory, radiology, emergency room, office, and kitchen do not have an accessible operable window nor is there an operable ventilation system in the clinic to provide ventilation air to these spaces. The existing ventilation system serving the remaining rooms in the clinic is old, not operational, and essentially abandoned.
- b. Outside Air: Some of the rooms with operable windows have broken or missing operators so the windows cannot be opened.
- c. Exhaust Air: Ceiling mounted exhaust fans service the toilet rooms. These fans are operational and are ducted outside. The laboratory and janitor's room are not provided with an exhaust fan. The kitchen range is not provided with a code required range hood and exhaust fan. The existing exhaust fan for the x-ray darkroom is not operation and does not provide the required exhaust air as required by code.

Description: **Provide ventilation for clinic.**

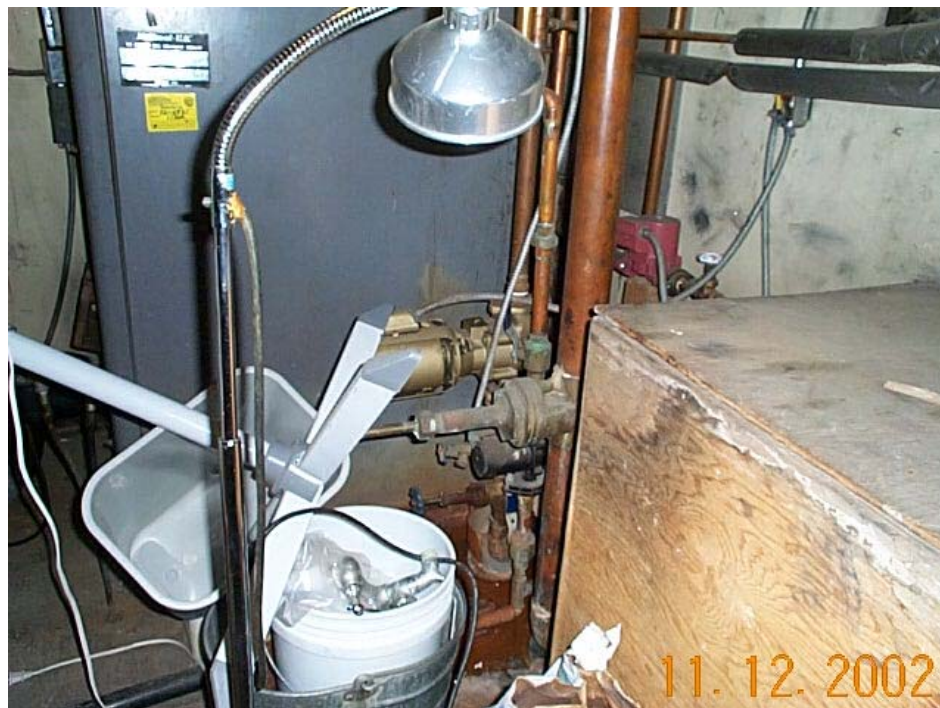
Reference  
Number: **Msk08**

A large number of boxes, parts, equipment, etc. are stored in the boiler room making access for inspections, maintenance, and repair difficult.
- c. Heat Distribution System: The heating piping has been routed in the ceiling space of the clinic. The baseboard enclosures and convectors are all in poor condition. The entire heating system is in need of replacement.

Description: **Remove stored items from boiler room.**

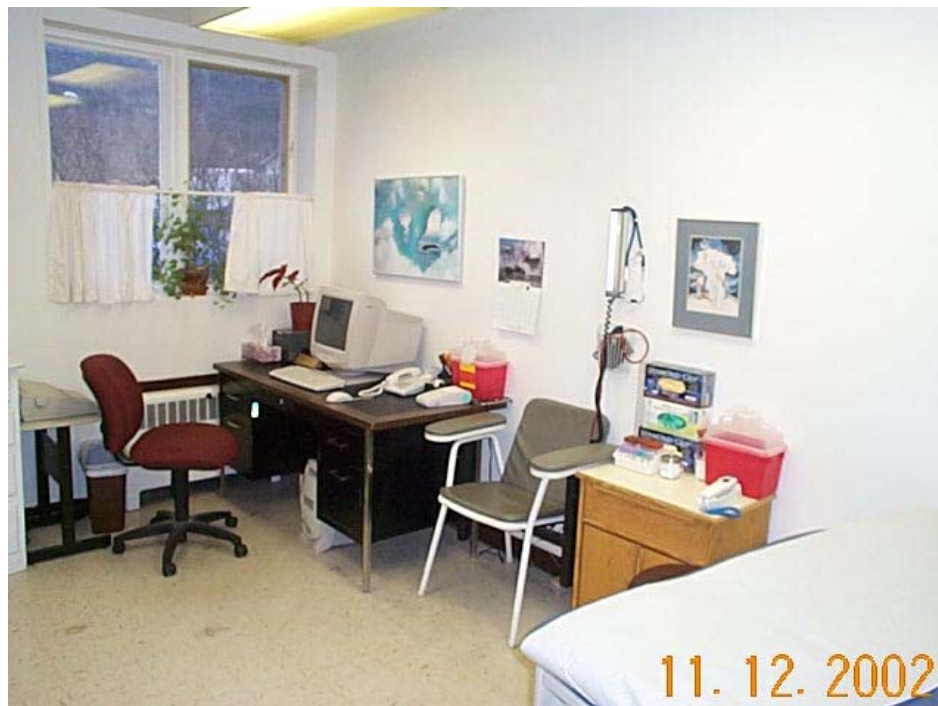
Reference  
Number: **Msk10**

Description: **Exam Room without washing facilities**

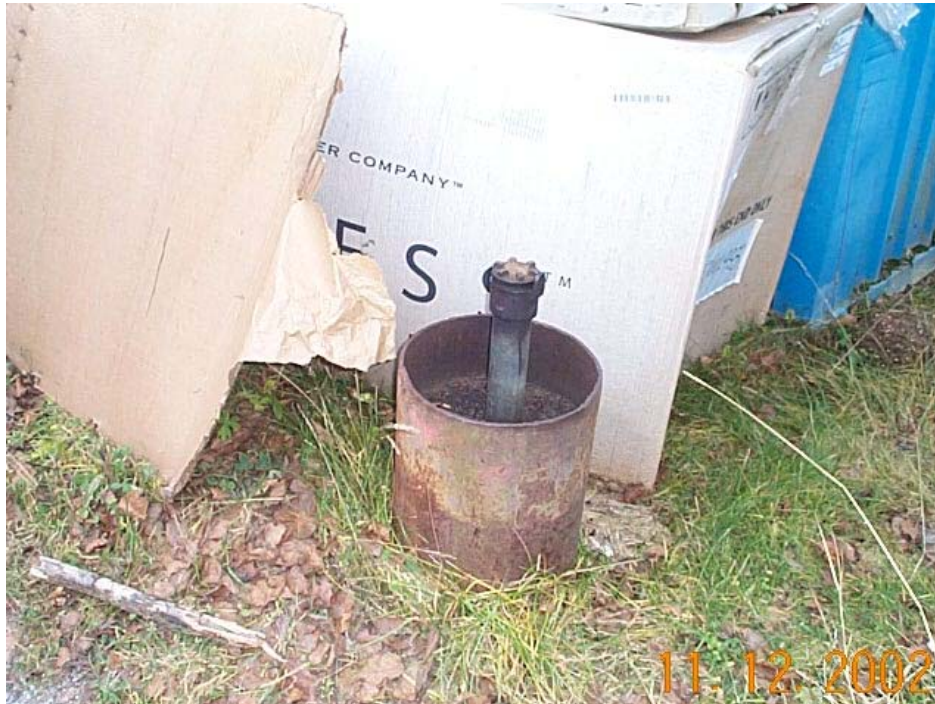
Reference  
Number: **Msk12**

- a. Fuel Storage and Distribution: The clinic's heating fuel oil storage tank is located below ground adjacent to the building. This underground fuel oil storage tank is 35 years old, is leaking fuel into the ground, and needs to be replaced. The tank does not meet IFC requirements for piping (IFC section 2206.6.3), venting (IFC section 3404.2.7.3), and tanks (IFC section 2703.2.4)
- b. Boilers: A single commercial grade, oil-fired boiler provides heating for the entire clinic. The boiler is 35 years old, in poor condition with missing controls and systems that are required by code. There is severe corrosion on the boiler stack and the vent assembly is in poor condition. There is a combustion air opening for the boiler which is not constructed to code. There are no additional heaters in the clinic to assist with heating.

Description: **Fuel oil storage tank and piping**

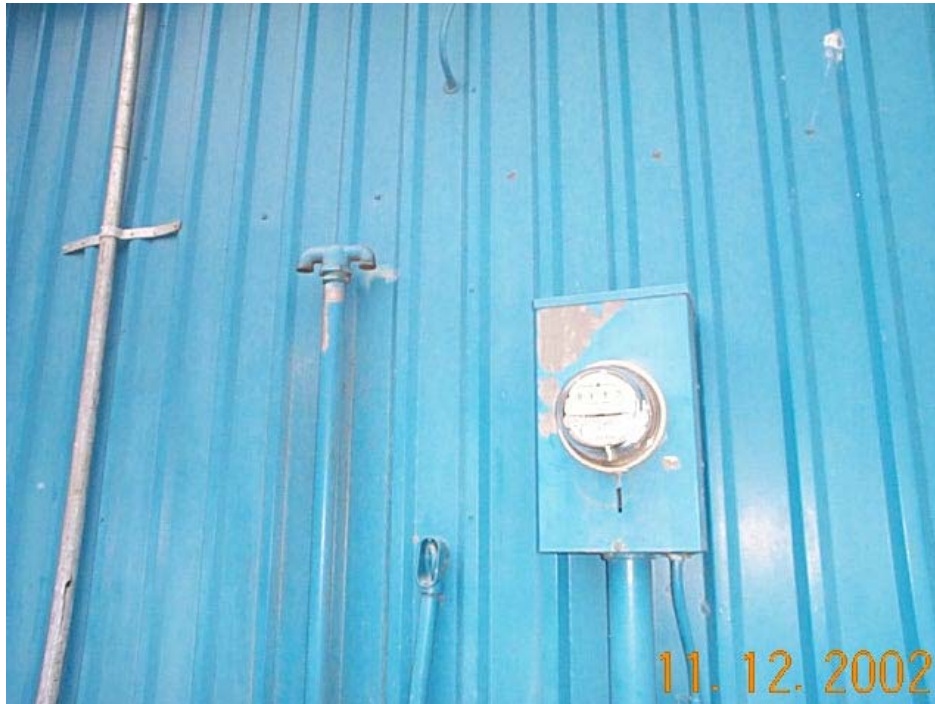
Reference  
Number: **Esk01**

- a. The building does not have a grounding electrode system and no bonds were found to the foundation, metallic piping etc.
- b. The metallic piping systems bond to the service could not be located as required by NEC 250.
- c. The patient care areas are not provided with a metallic raceway system and the insulated grounding conductor routed to each receptacle in accordance with the requirements of NEC 517.13 A and B.

Description: **Grounding deficiencies**

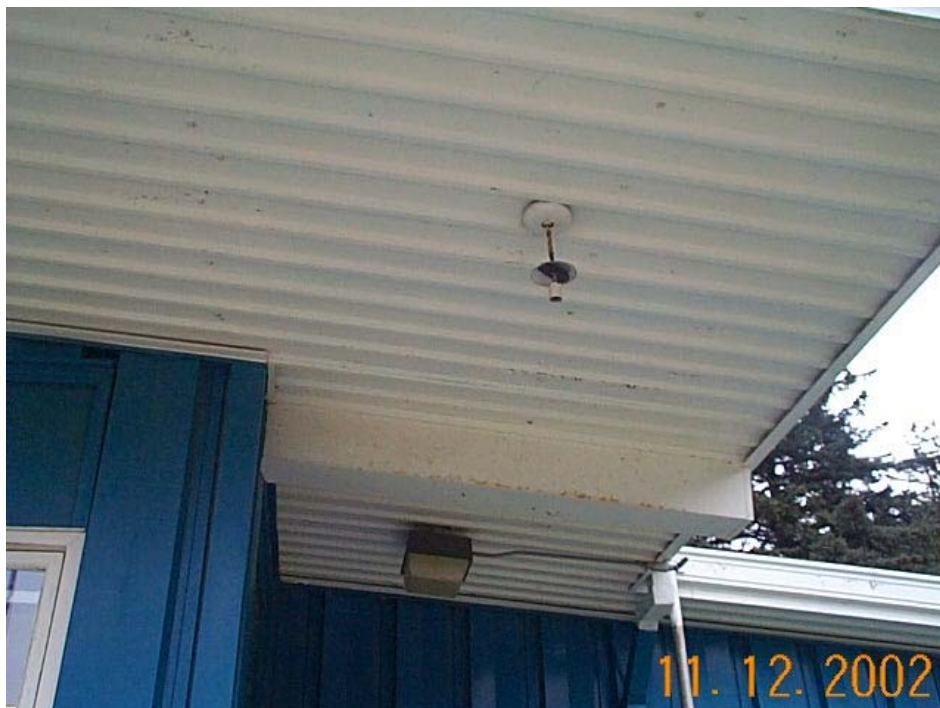
Reference  
Number: **Esk02**

Description: **Exterior lighting substandard condition**

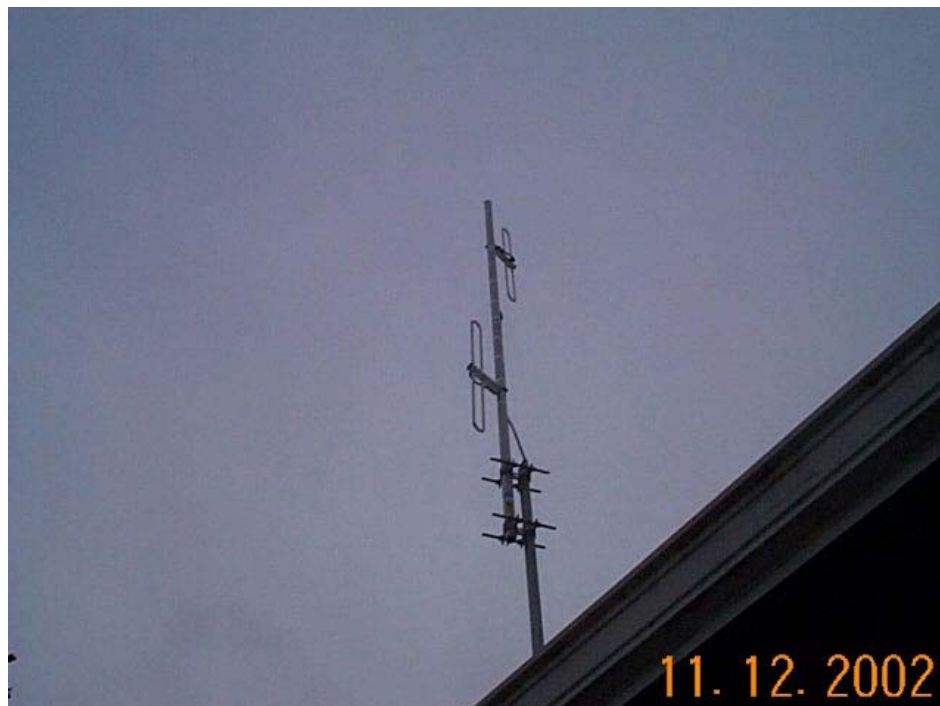
Reference  
Number: **Esk03**

Description: **Main feeder deficiency**

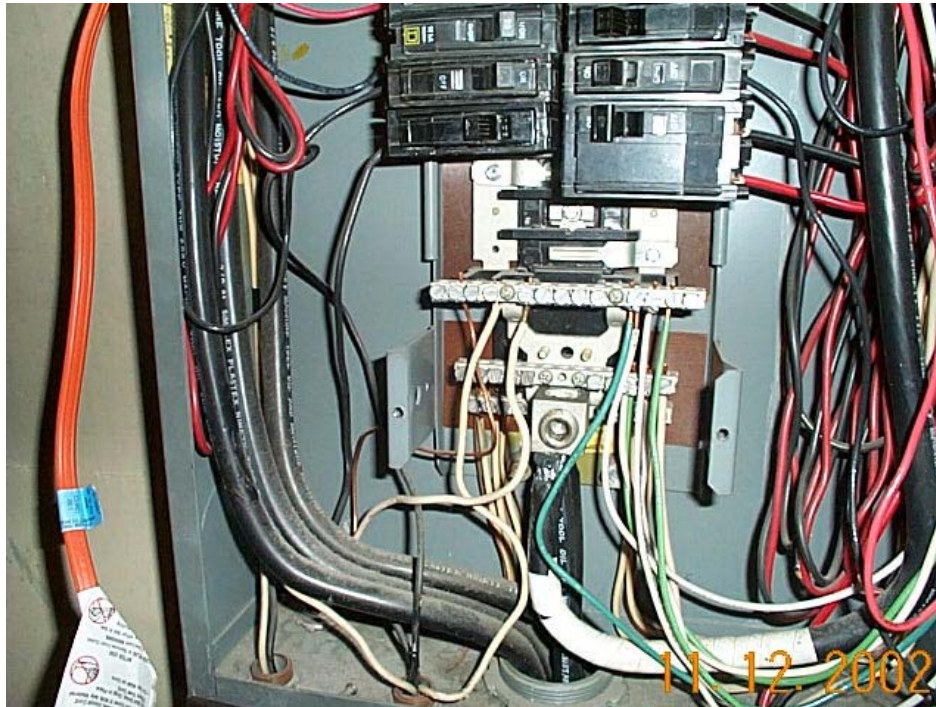
Reference  
Number: **Esk04**

Description: **Branch circuit wiring to patient care areas.**

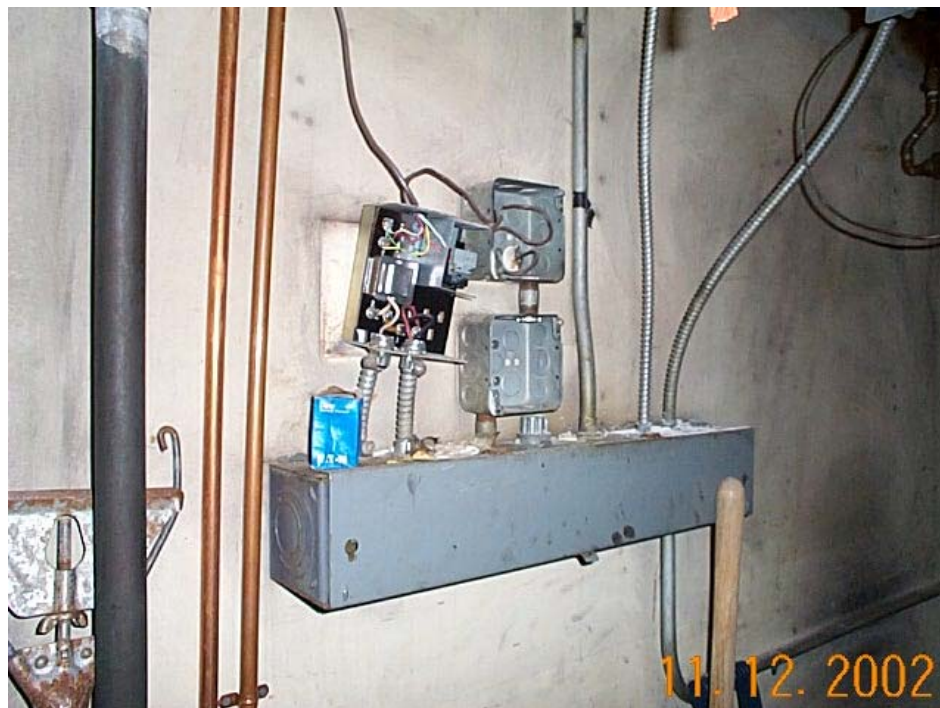
Reference  
Number: **Esk05**

Description: **Open wiring splices and open junction box**

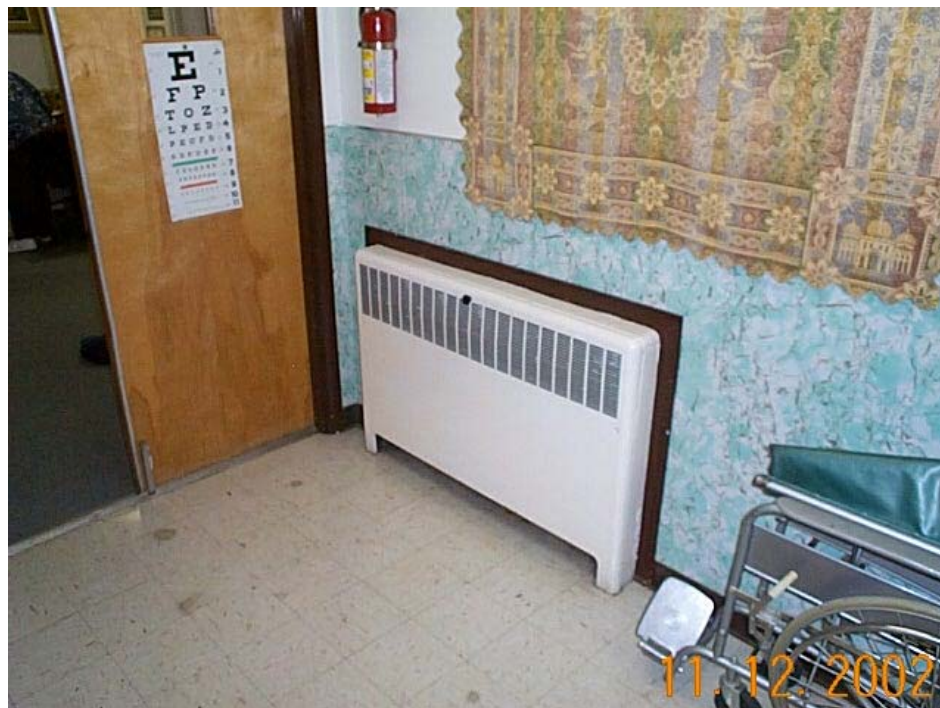
Reference  
Number: **Esk06**

Description: **Fire alarm not installed**

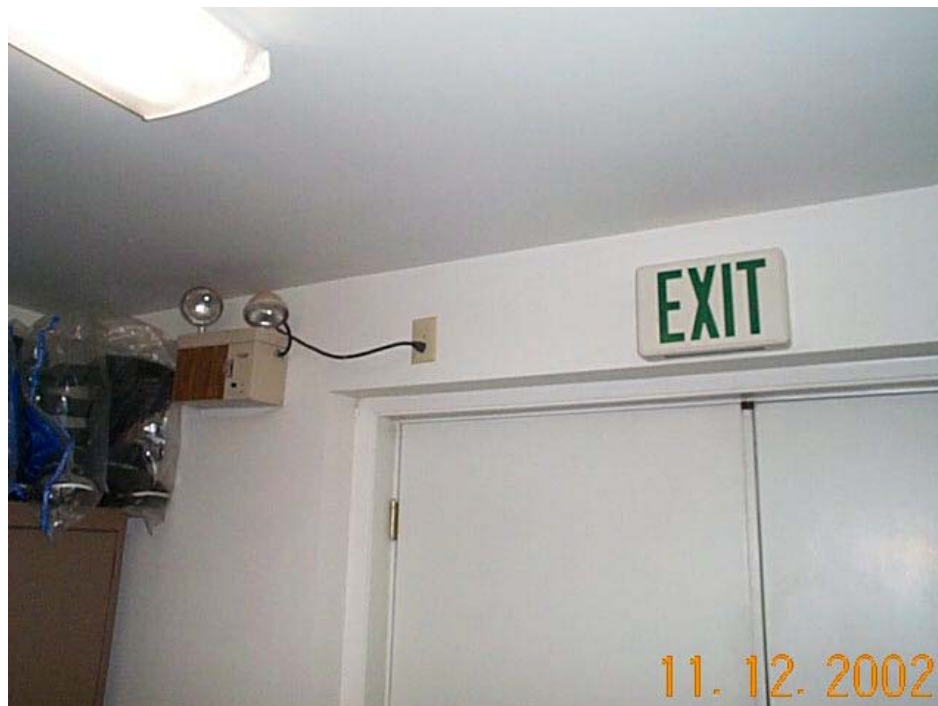
Description: **Exit sign and emergency egress deficiencies**

Reference  
Number: **Esk08**Discipline: **E**Deficiency Code: **02**  
(Fire/Life Safety)Photo Roll/Frame:  
**Esk08.jpg**Estimated Total Cost:  
**\$14,873****Narrative Description of Observed Deficiency/Problem:**

One emergency light failed during a 15 minute test. And no exit signs were provided in the mental health or dental clinic portions of the building. NEC 700.12.

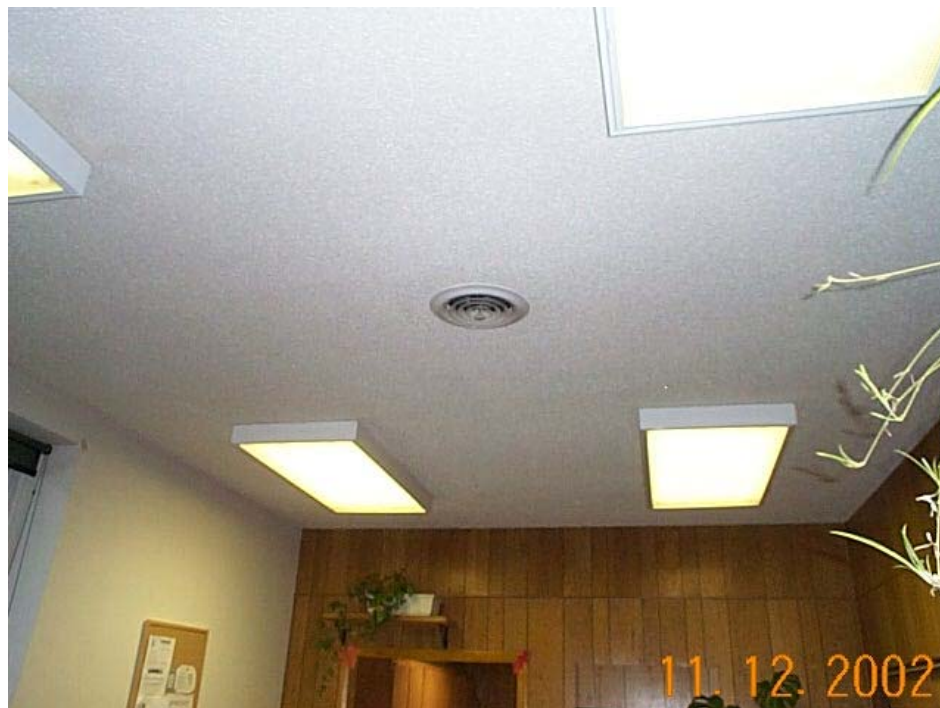
Reference  
Number: **Esk09**

Description: **Interior lighting substandard condition**

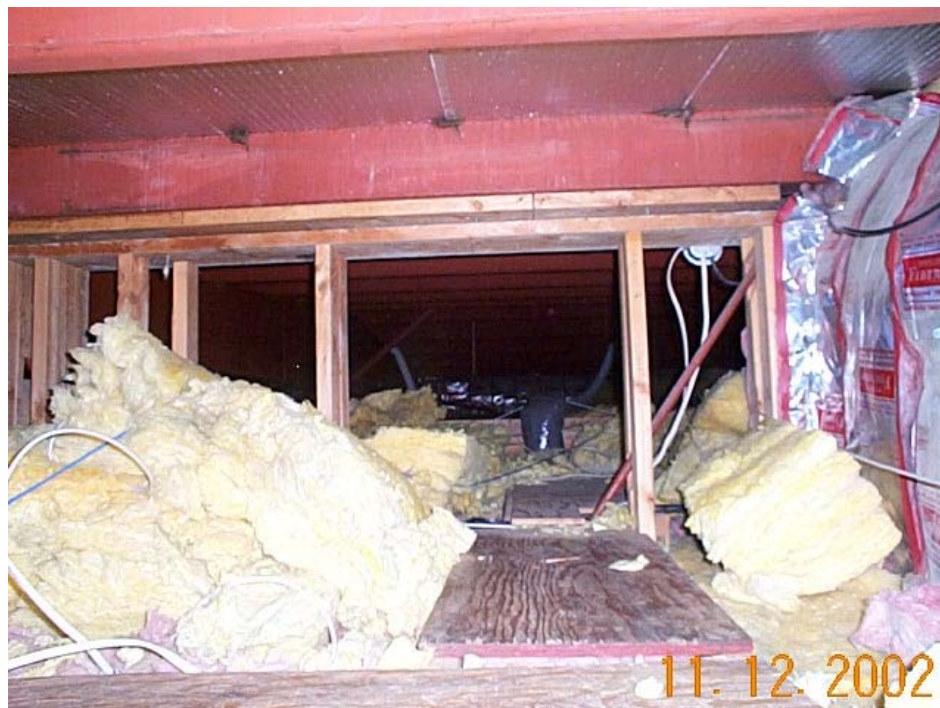
Reference  
Number: **Esk12**

Description: **Unsupported and un-protected attic wiring**

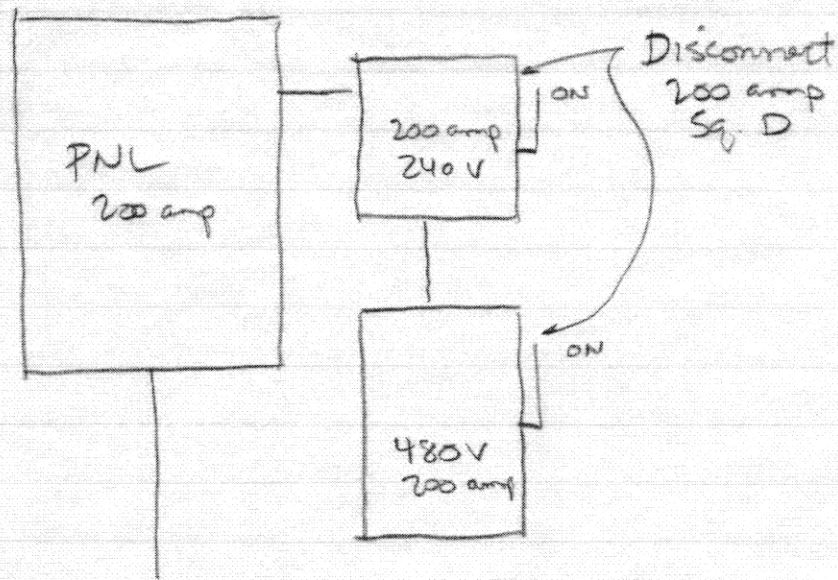
Generator located in outside building  
↑ (not used or tested - per users)
